INGREBOURNE  
COUNTRY CLUB

# 'Ben on the Course'

Welcome to my Spring / Early Summer Update

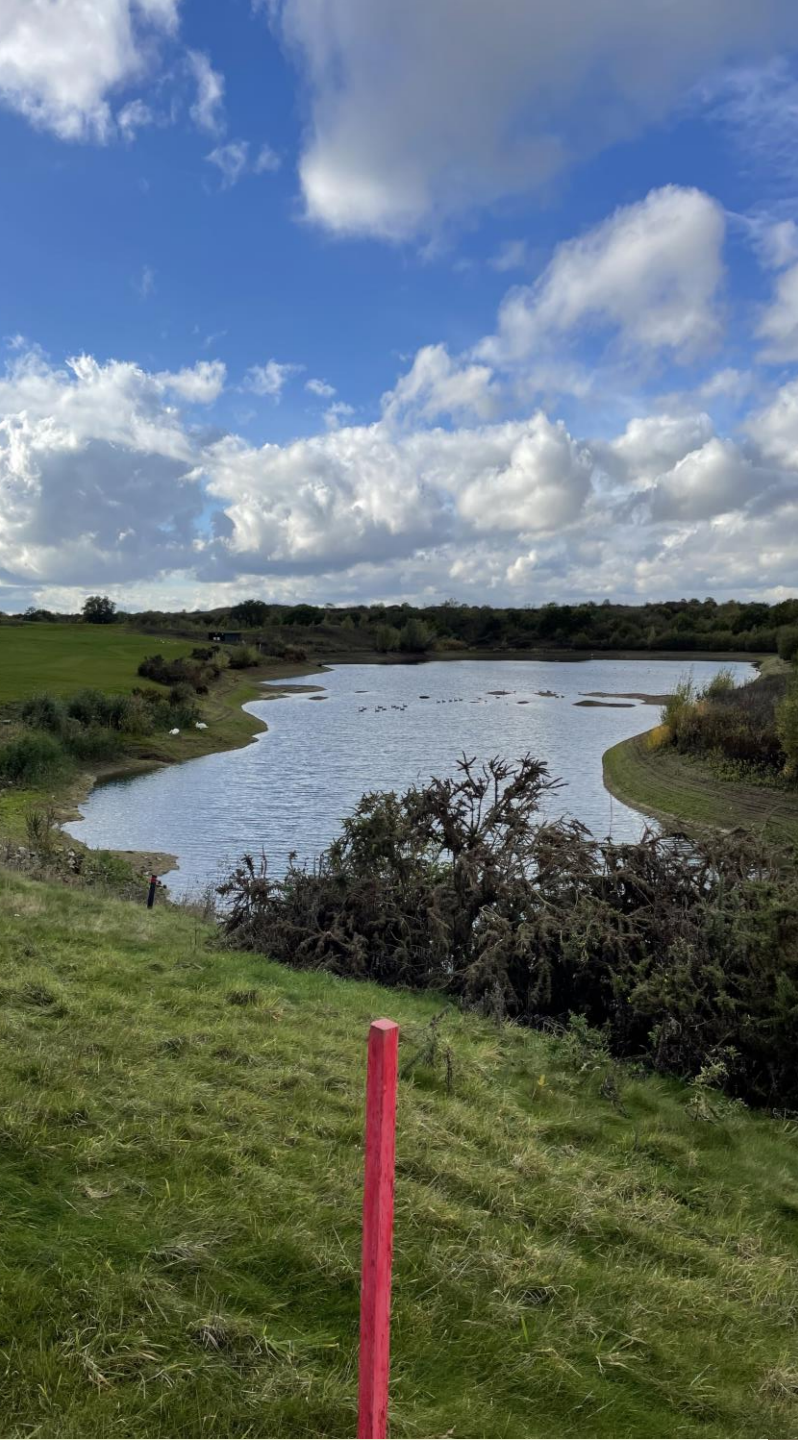
The picture to the left shows the irrigation reservoir at the end of last September 2023 – virtually  $\frac{3}{4}$  empty.

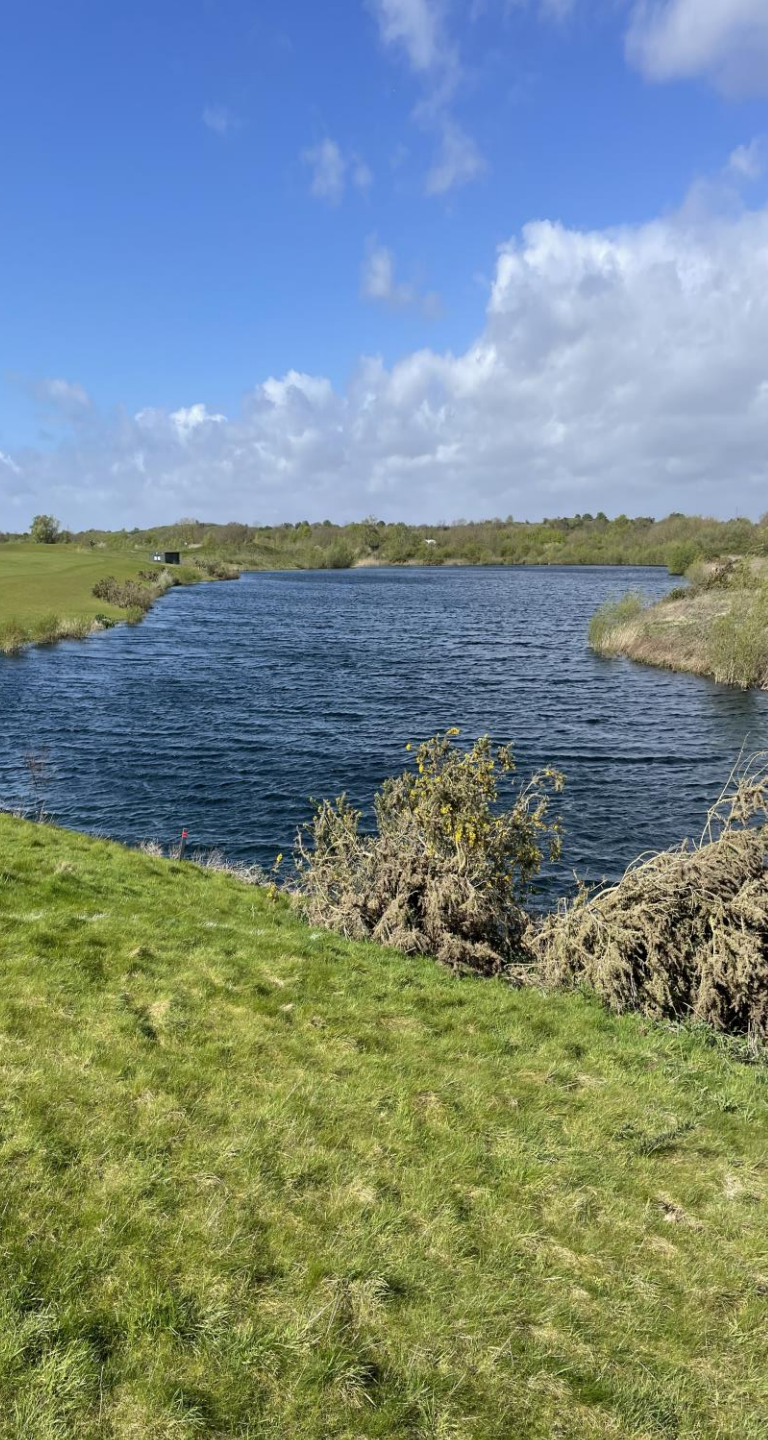
And this picture was taken a couple of weeks ago ! We have had thousands of m<sup>3</sup> of rainwater on our course – The reservoir has never been this full to the point of overflowing – but the rain keeps falling ! Although the irrigation system is primed up and ready to go, we haven’t needed to use it so far.....

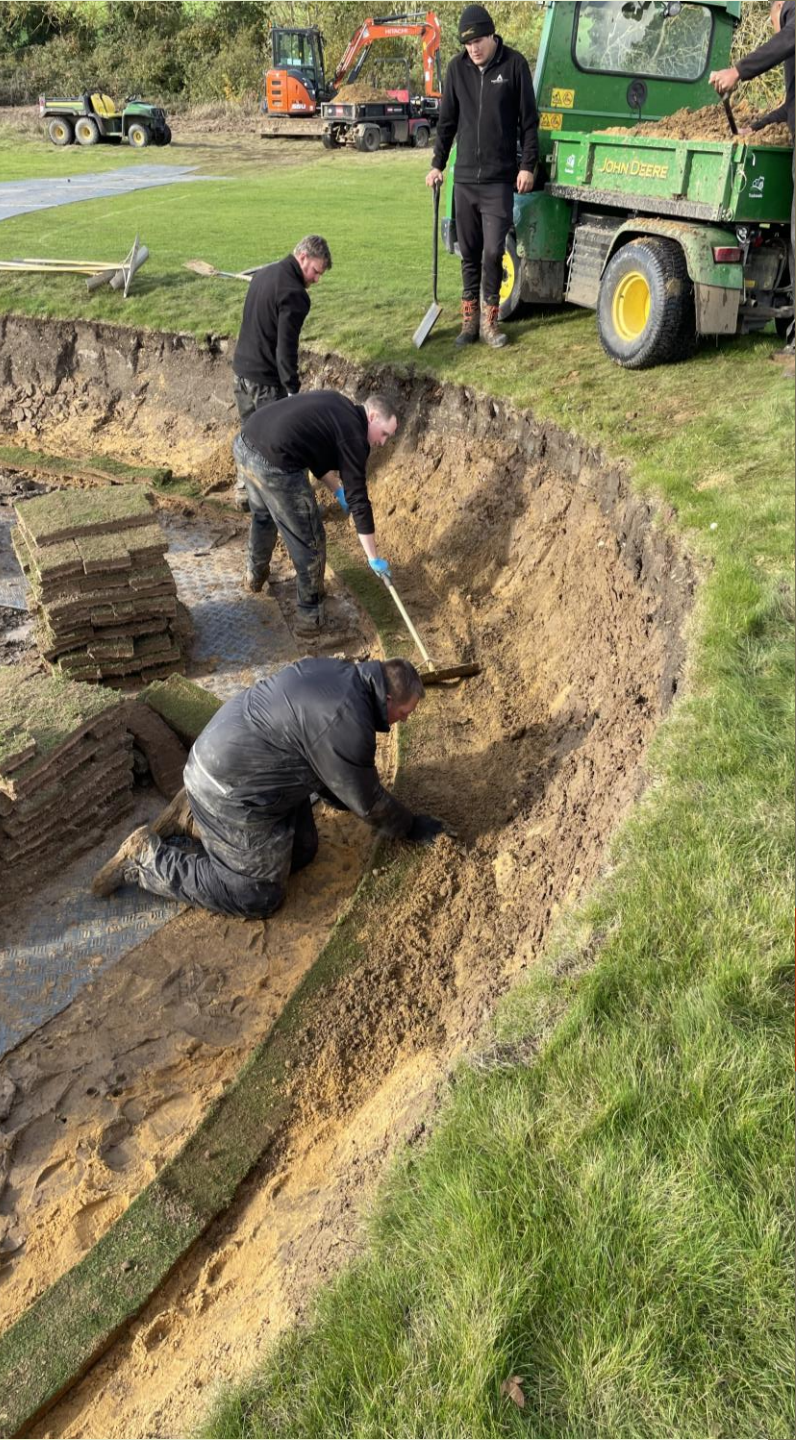
We have been able to get on with a lot of projects during this past off season. The bunker on the approach to 3<sup>rd</sup> North green was one of them.

Work started last October with the removal of the original timber facias and the introduction of a links style ‘revet’ face.

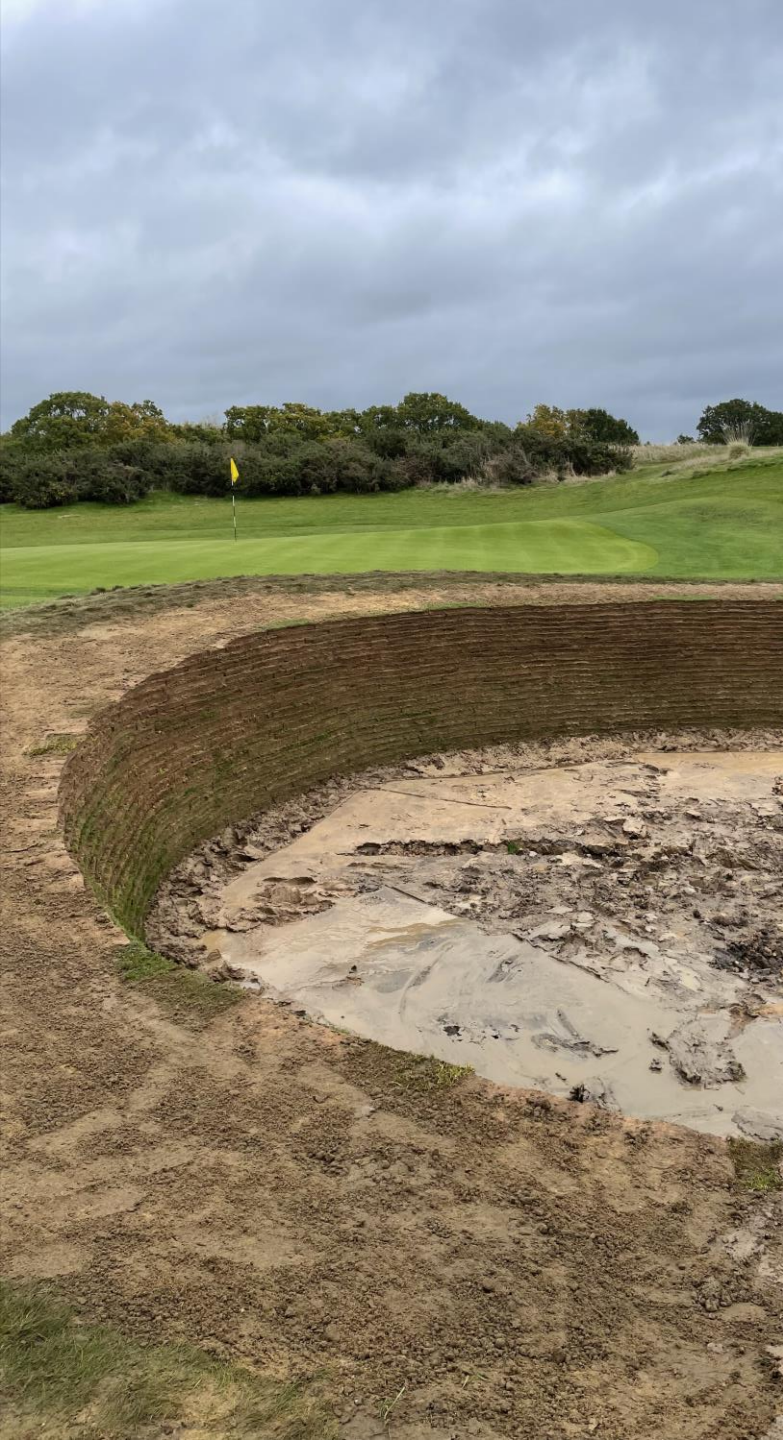
Slowly but surely the face was constructed, and the bunker base was shaped up and connected to the drainage.

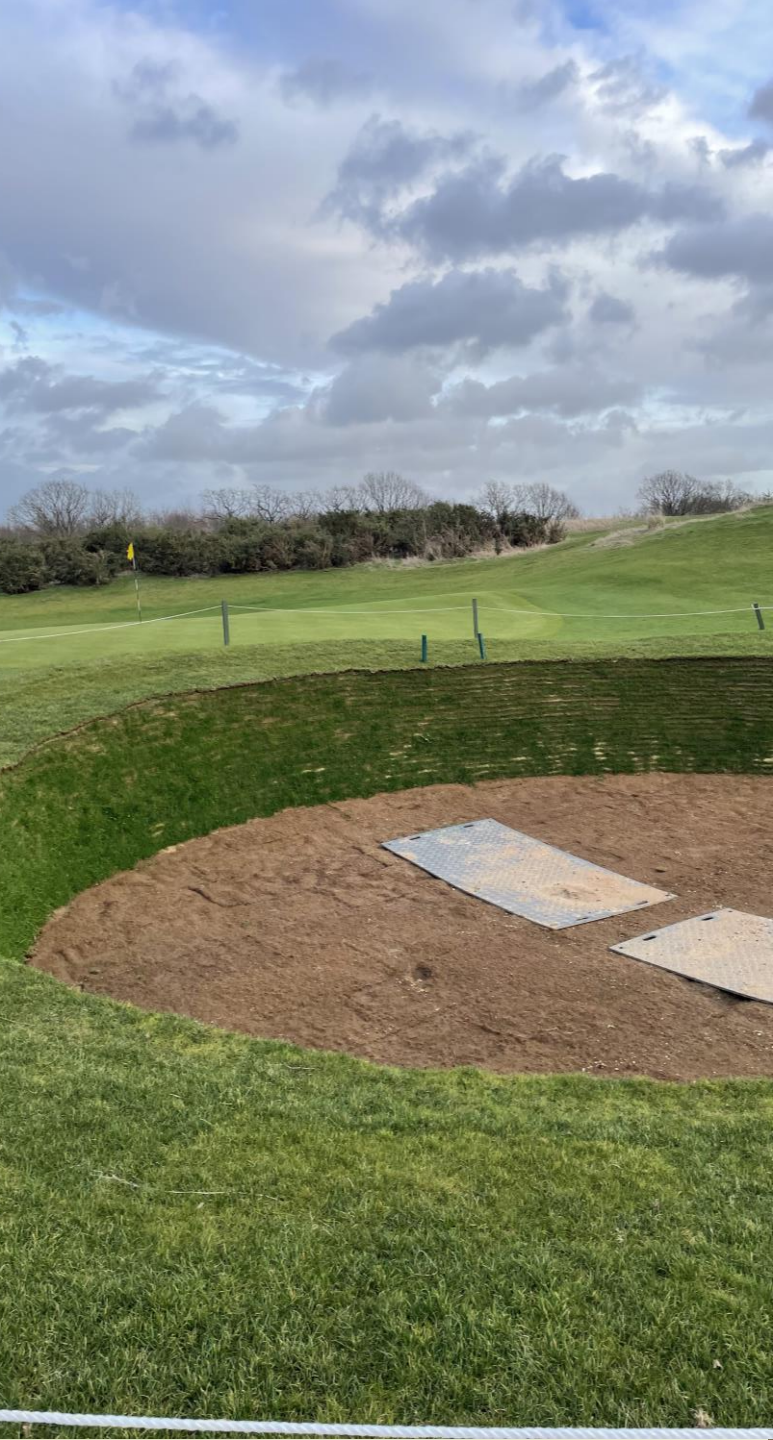
Area turfed and knitting in. Base prepared awaiting a dry period for sand.

We introduce sand at 50mm depth to start with and follow up with two applications of 25mm to build up the bunker surface.

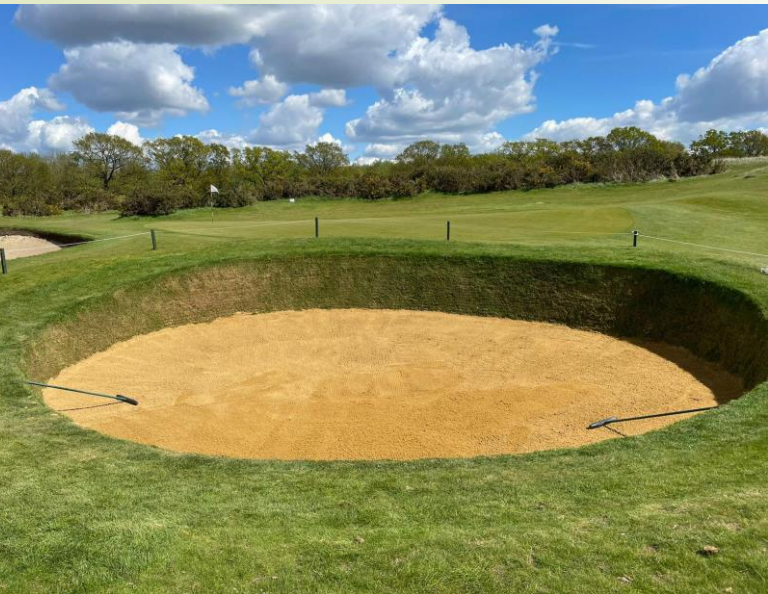
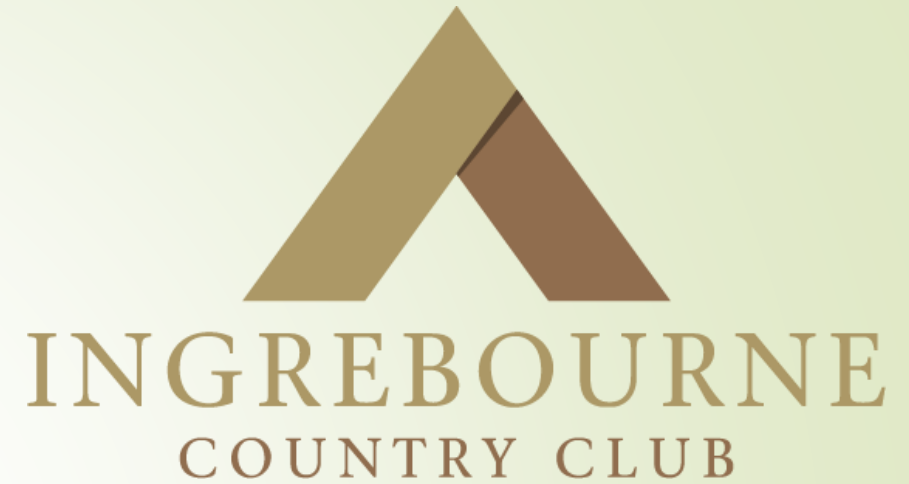
The finished product !

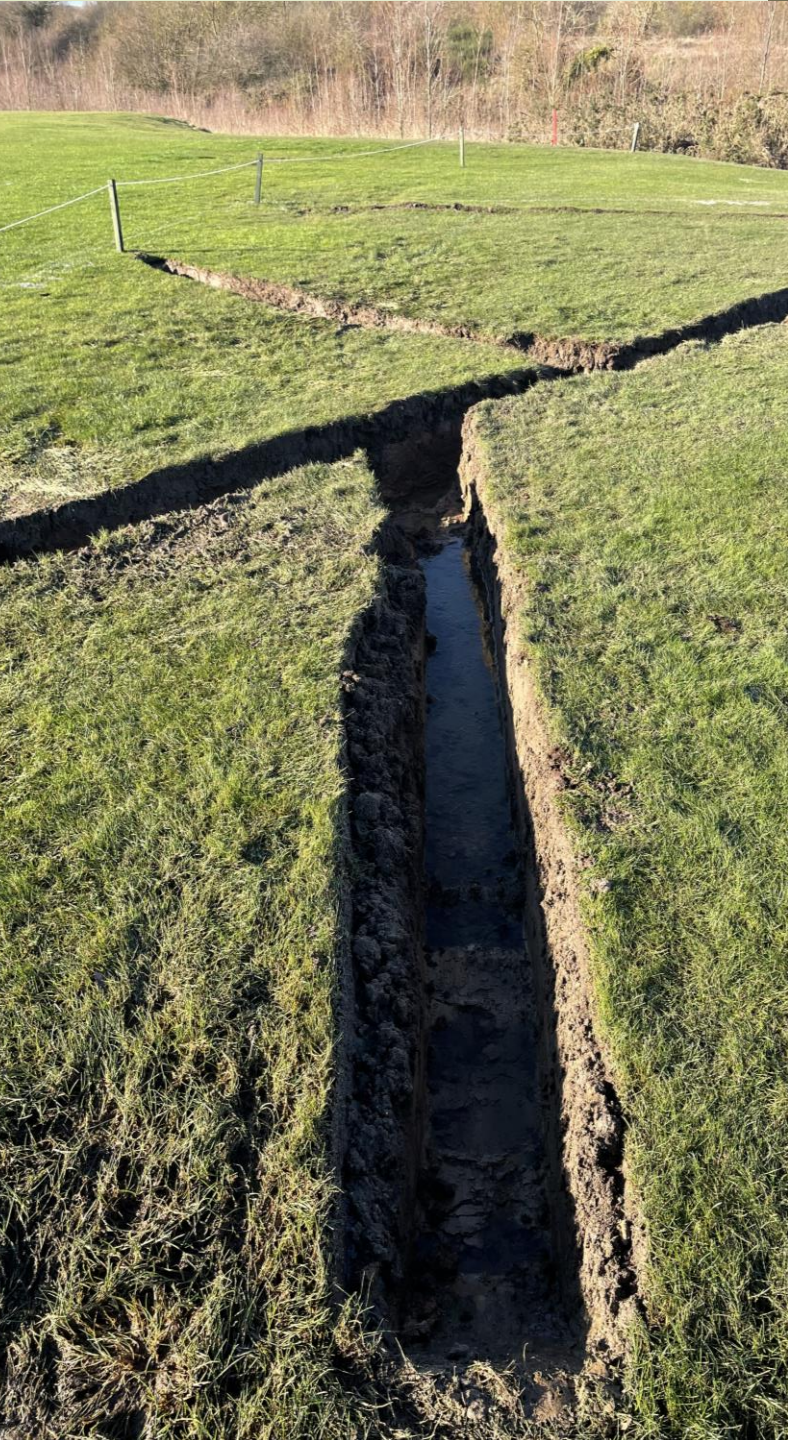
This year fairway drainage has been a priority.

We identified areas (and there are many) where additional drainage would be helpful. Overall, we have installed more than 500m of secondary drainage in known areas. You will see our work on the 1<sup>st</sup>, 5<sup>th</sup> and 10<sup>th</sup> holes.

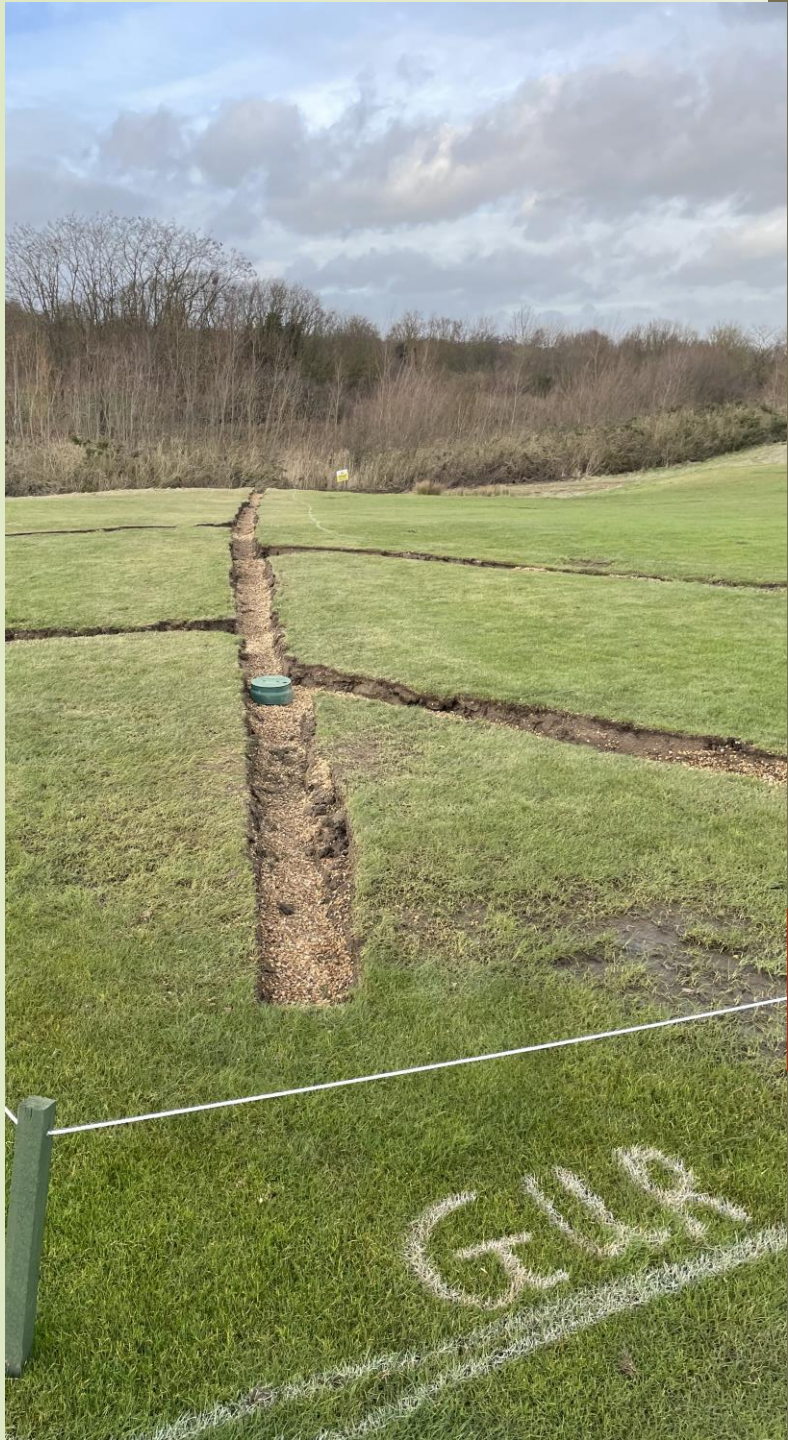
We trenched these areas systematically – added 100mm drainage pipe to a positive outlet then overlaid with gravel and rootzone.

Catch basins were strategically placed to maximise the drainage and catchment area.

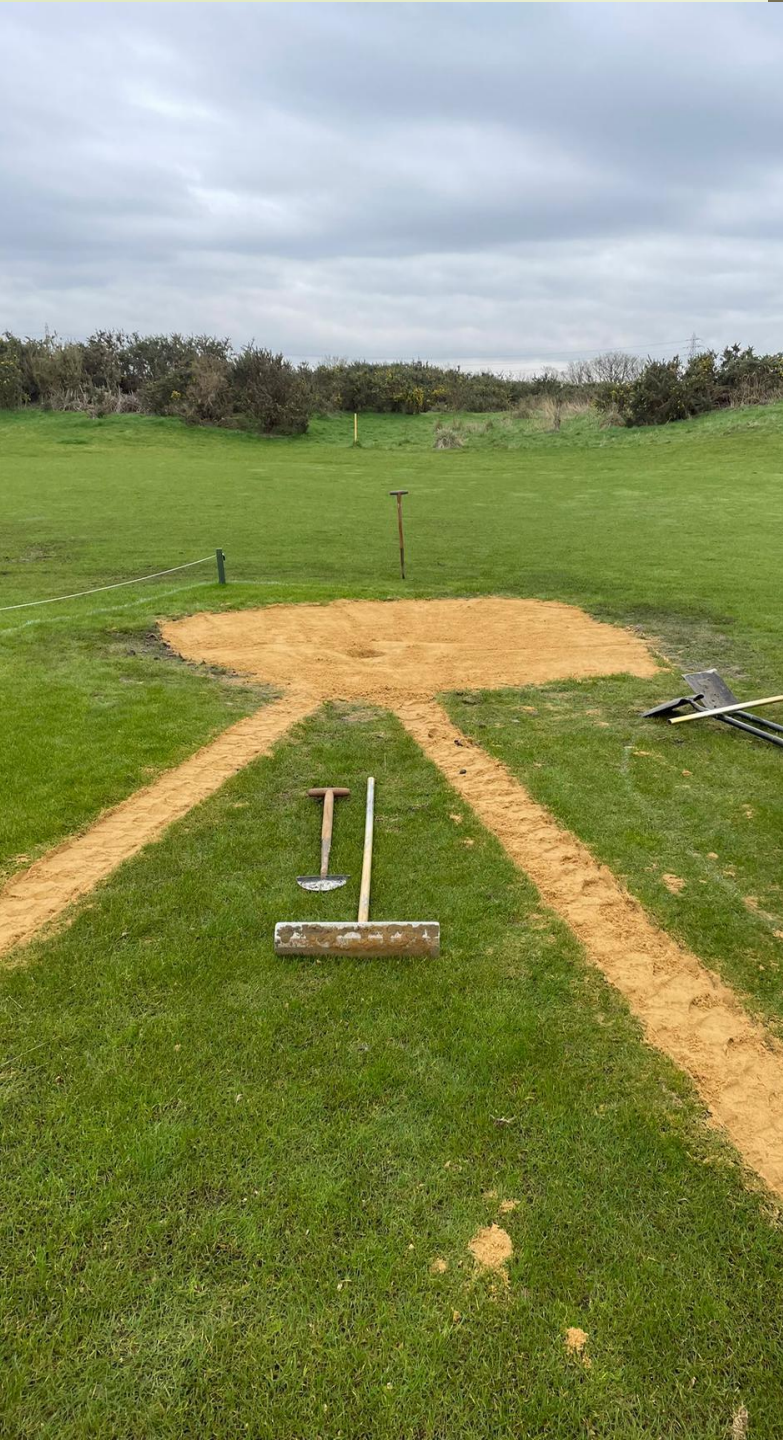
Some areas we trenched to a local soak away which allowed us to pick up on large surface areas.

Each drainage run was different, but I'm pleased to report they are working well.

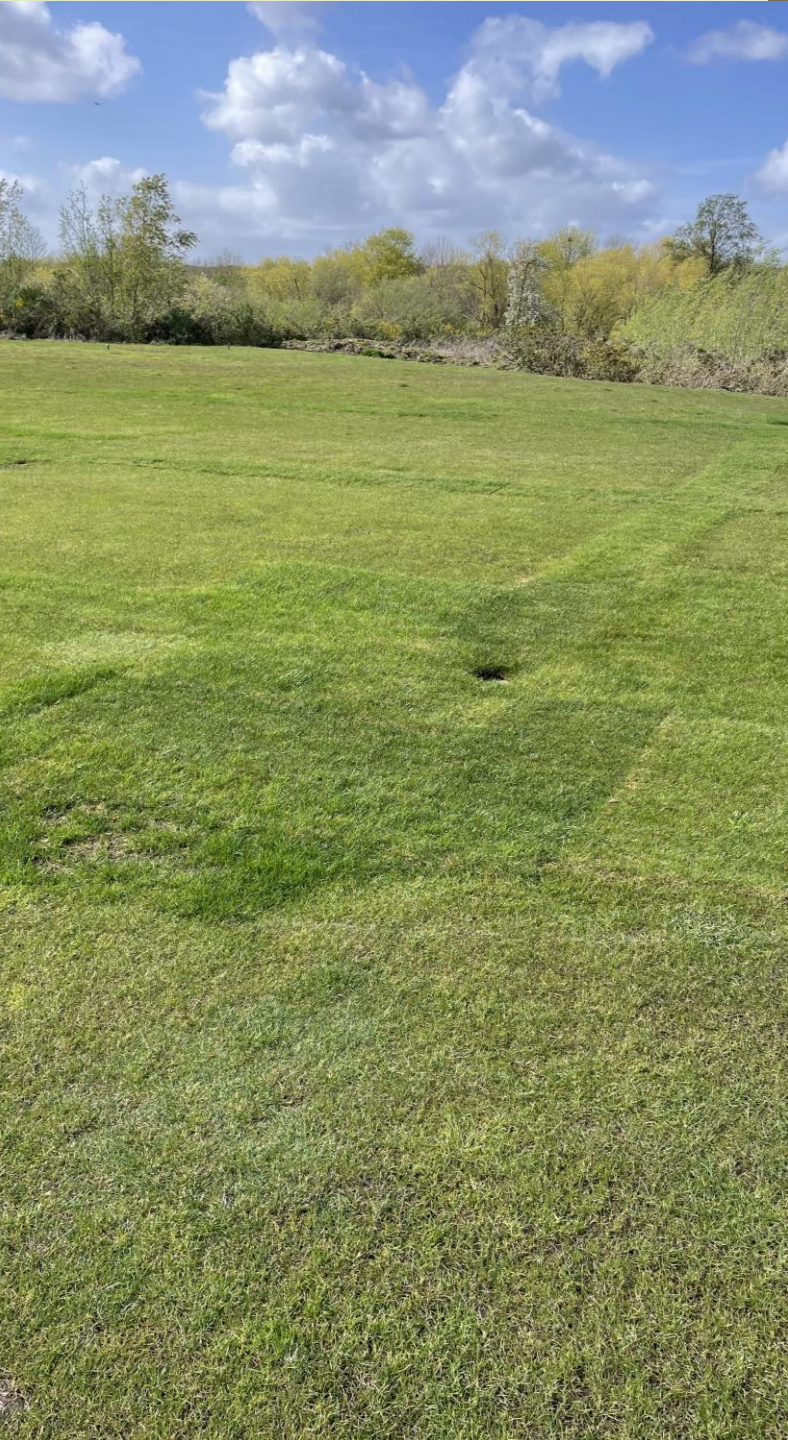
Very pleased with the outcome and the immediate benefits from better drainage.

Our plan is to continue this process during the winter months, focusing on the known wetter areas. It's a time-consuming task but the benefits far outweigh.

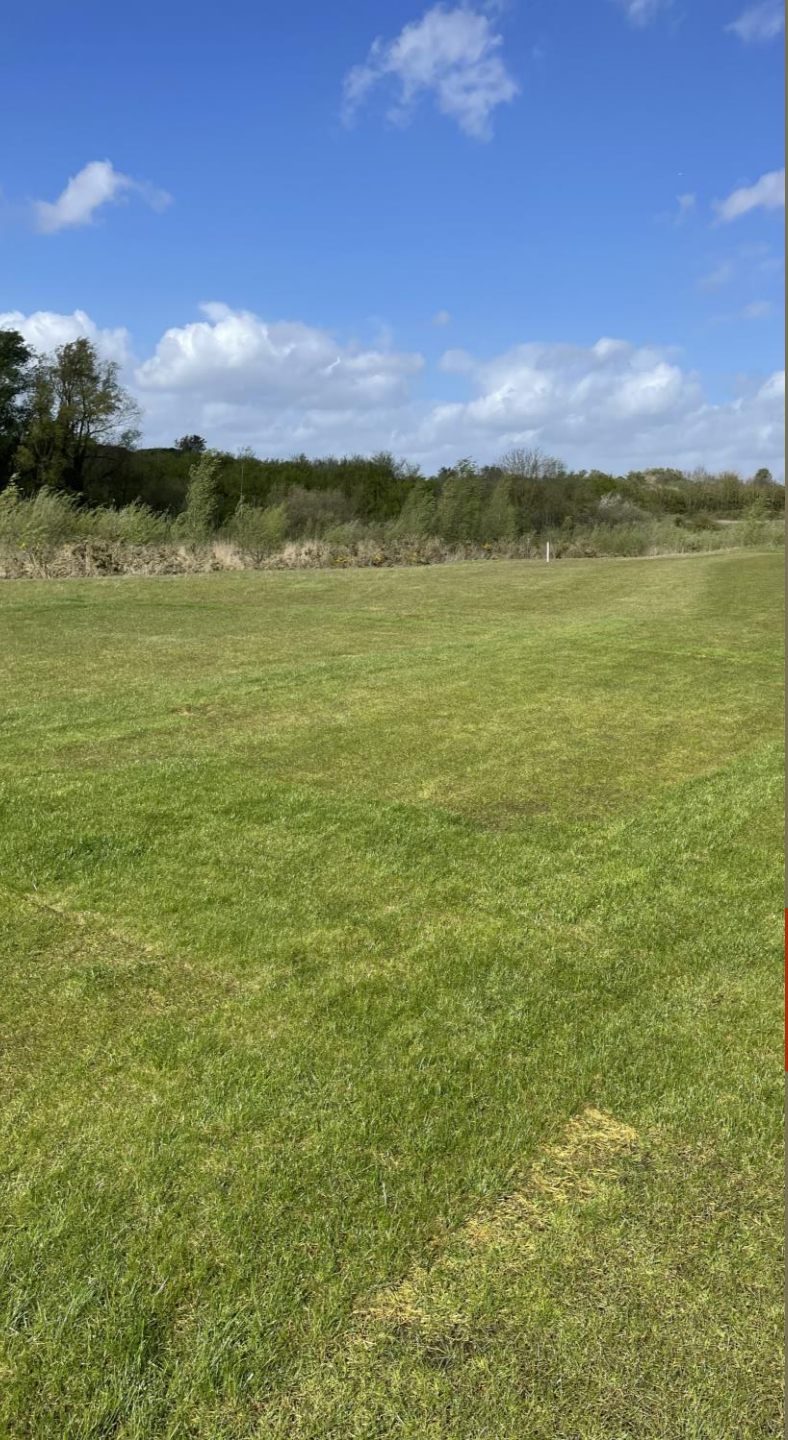
A few weeks on and the turf recovery over the new drainage runs is very good.

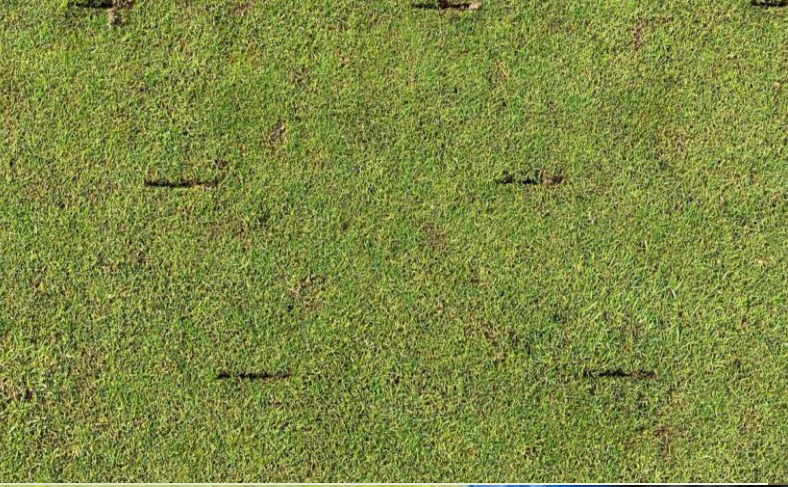
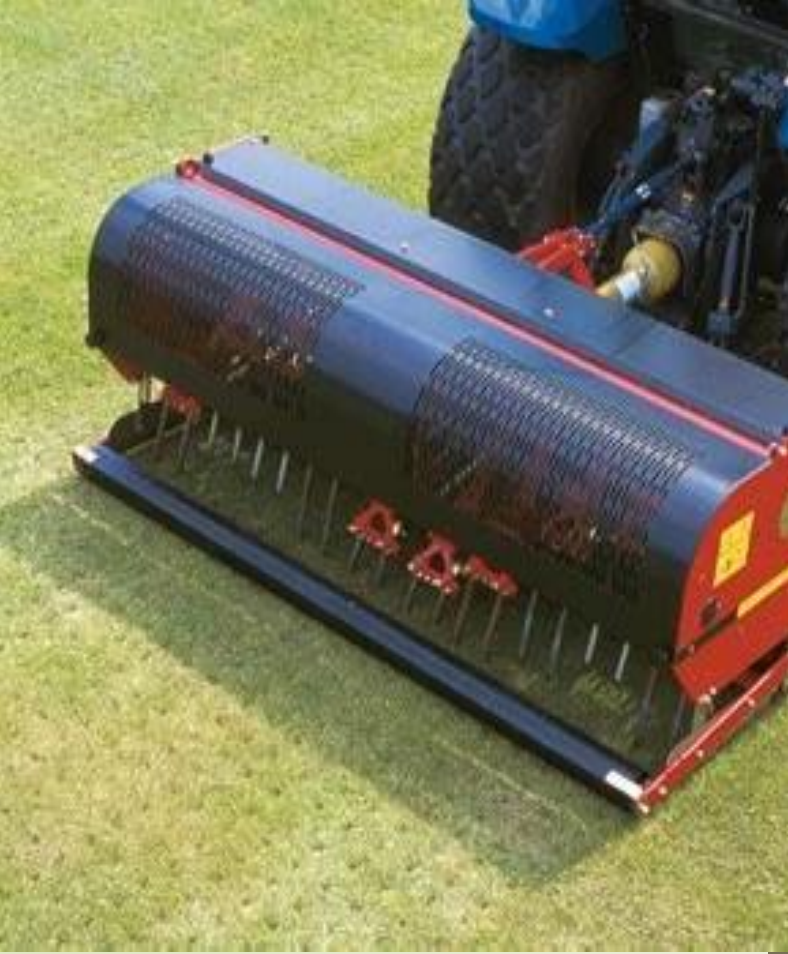
We hollow cored and slit our greens early this year and for once were lucky with the weather during that week.

Doing renovations earlier in the year offers us the opportunity for a less intrusive renovations in August when our green surfaces are at their best.

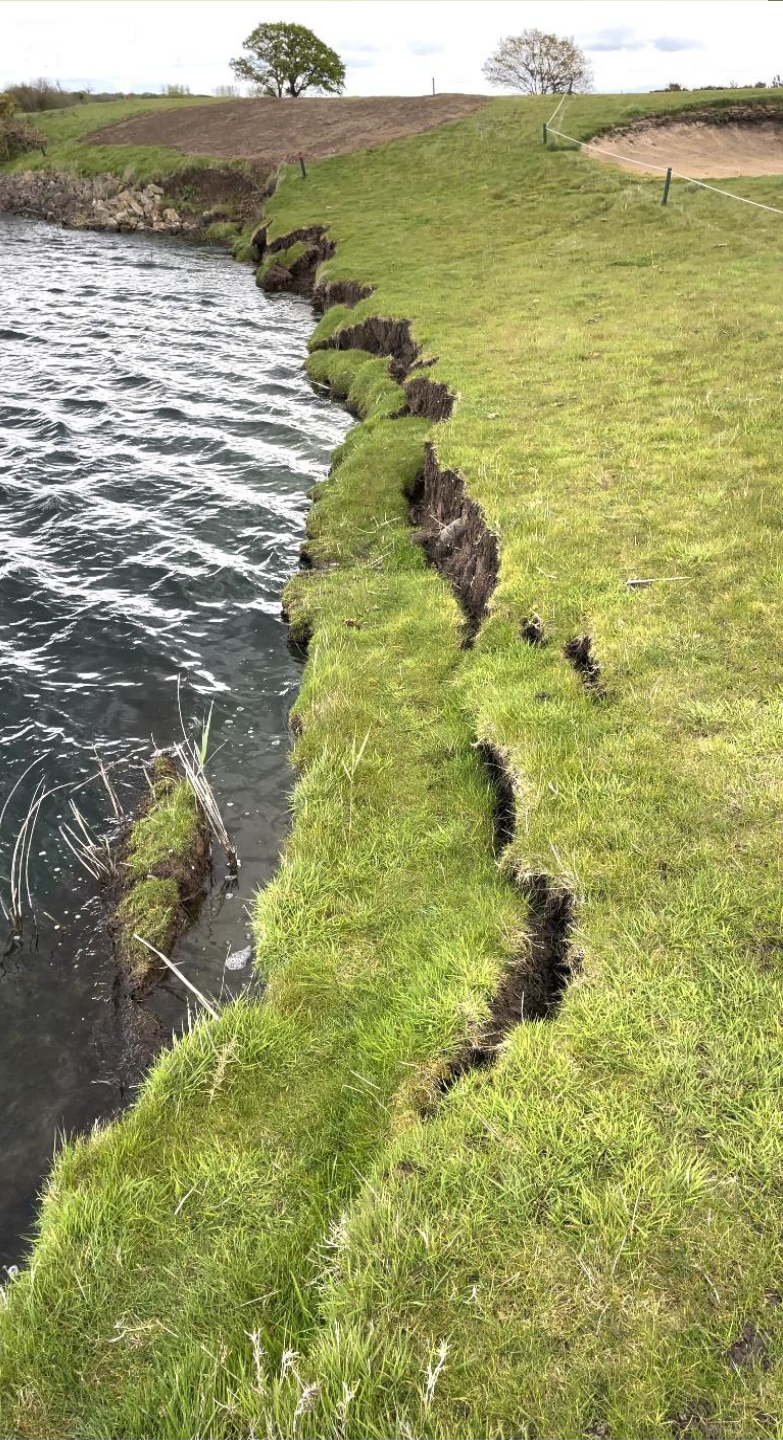
The left-hand side edge of the lake on the North 2<sup>nd</sup> hole has suffered subsidence and you will see that this has now been repaired.

We have taken the opportunity to fill in the far-left bunker as well. Our plan is to adjust the centerline of the hole slightly to the right so that the lake is further left when playing the hole. Either way it has been a good repair and will support the surrounding soils.

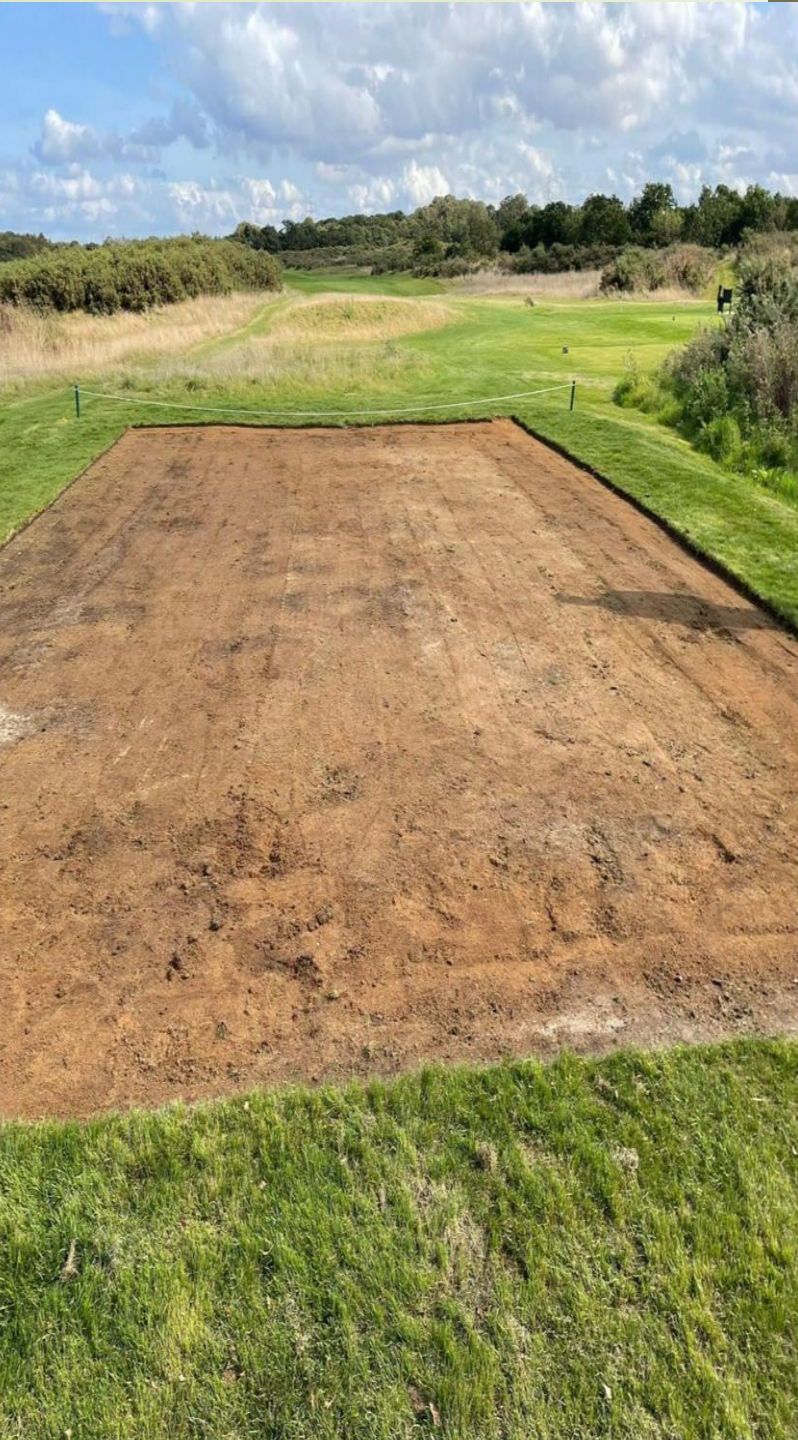
Last October we regraded, levelled and re-turfed the 13<sup>th</sup> tees (East 4). The back and middle tees had become uneven, so we took the opportunity to level them and, in that process, enlarged them as well.

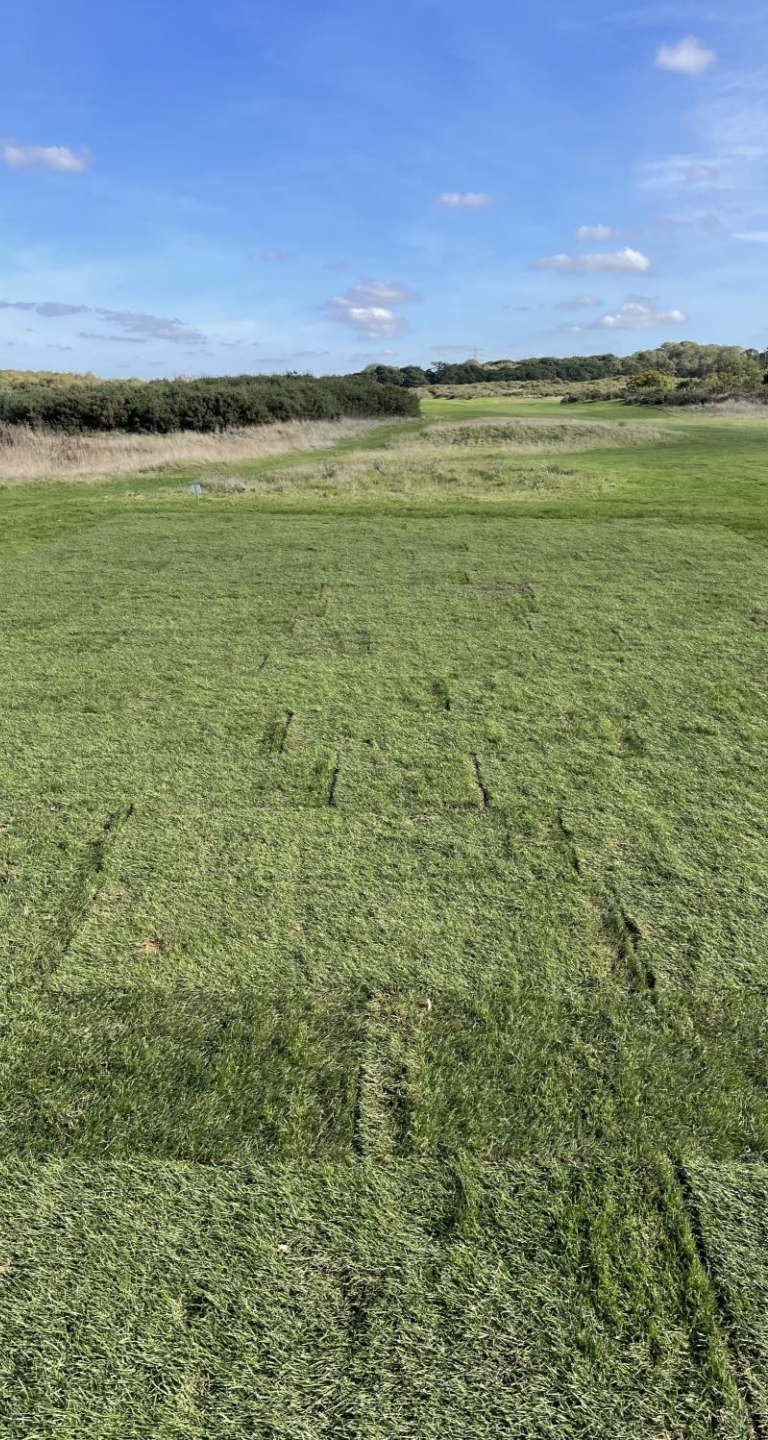
Pleased to report the turves have all knitted in and made for two super new teeing grounds. Again, our ongoing plan is to address other tees that require this type of work.
